# Duke Street Transitway

## Existing Conditions Report

**The City of Alexandria**

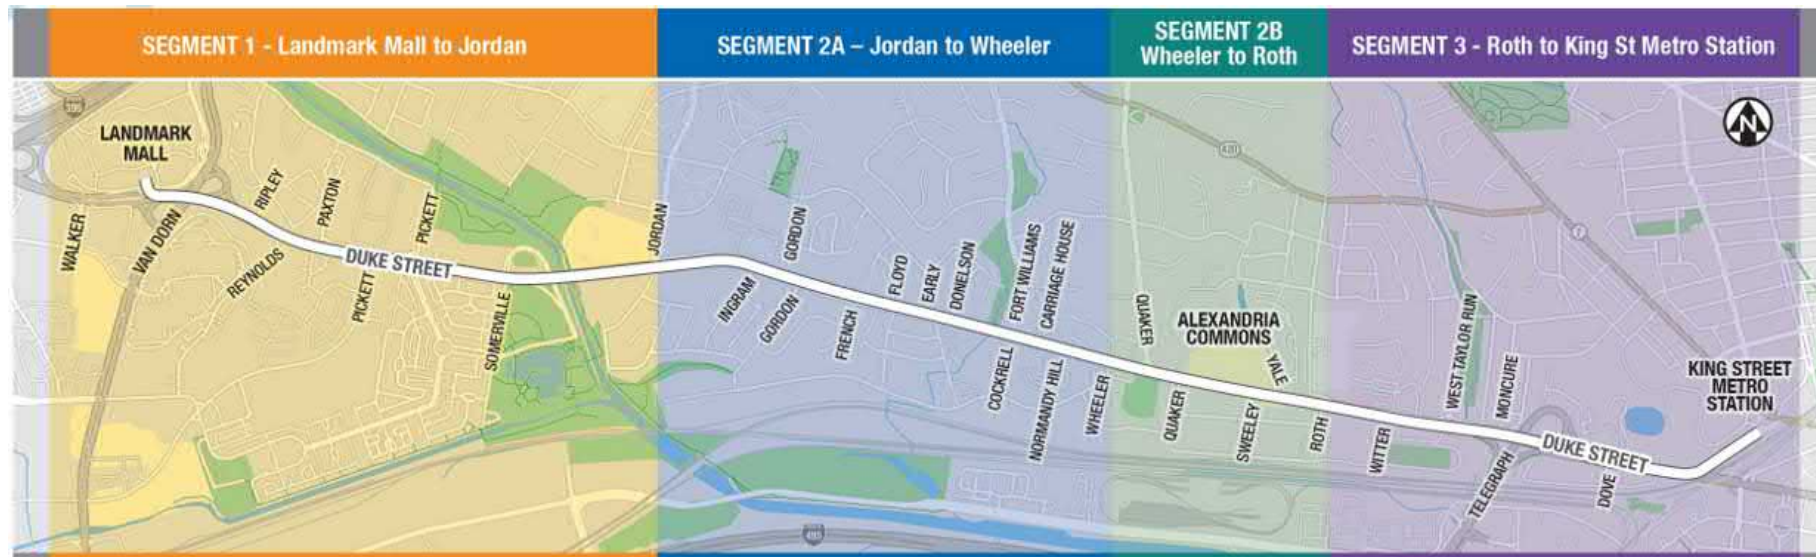
Figure 1: Duke Street Corridor Segments

The corridor is divided into four segments, referred to as Segment 1, Segment 2A, Segment 2B, and Segment 3 (see **Figure 1**). The termini of the segments are as follows:

- Segment 1: Landmark Mall (future WestEnd – Alexandria) to Jordan Street
- Segment 2: Jordan Street to Wheeler Avenue
- Segment 2B: Wheeler Avenue to Roth Street
- Segment 3: Roth Street to King Street Metro Station

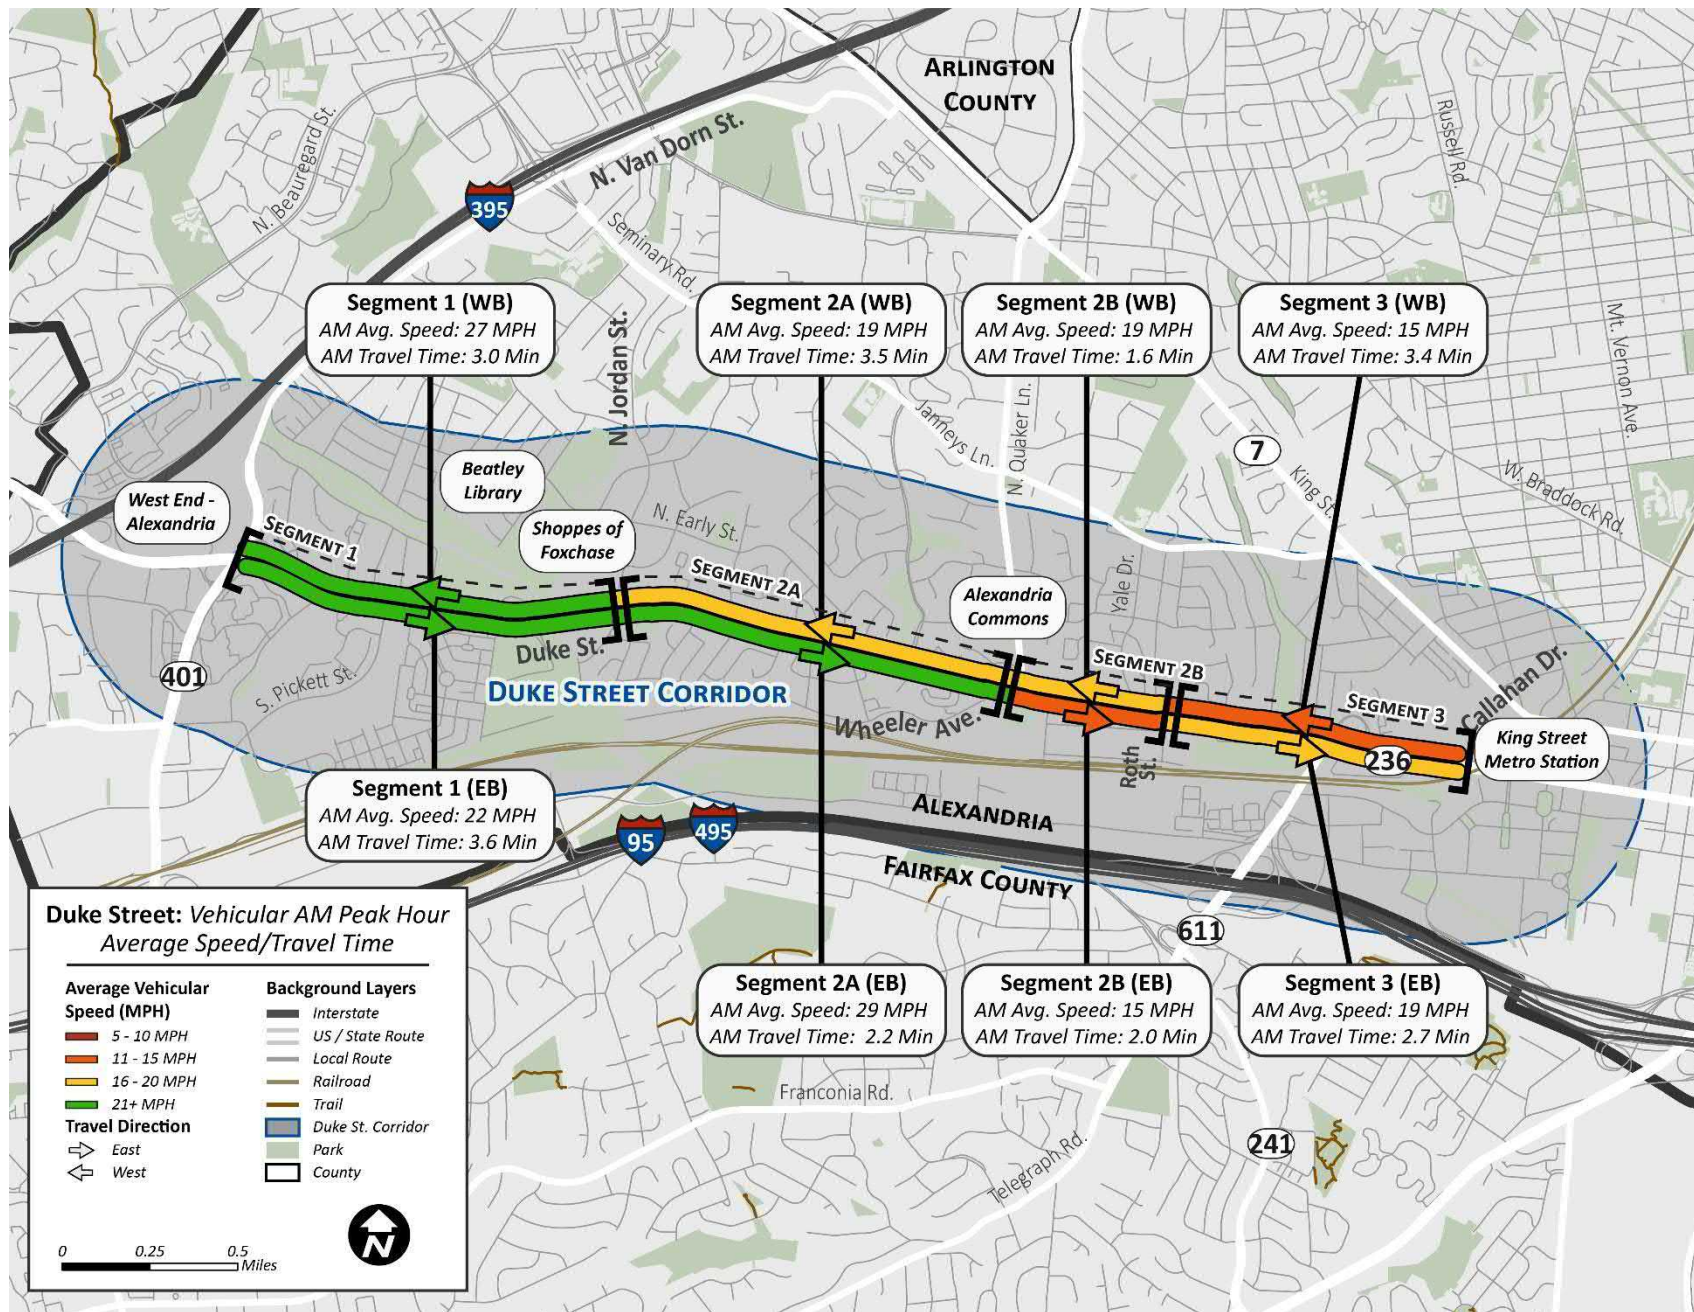
Figure 10: Average AM Peak Automobile Travel Time/Speed by Segment (Data Source: Field Travel Time Runs, May 2022)

**Figure 10** and **Figure 11** display AM and PM peak vehicular travel times and speeds, respectively. EB and WB conditions are displayed separately.

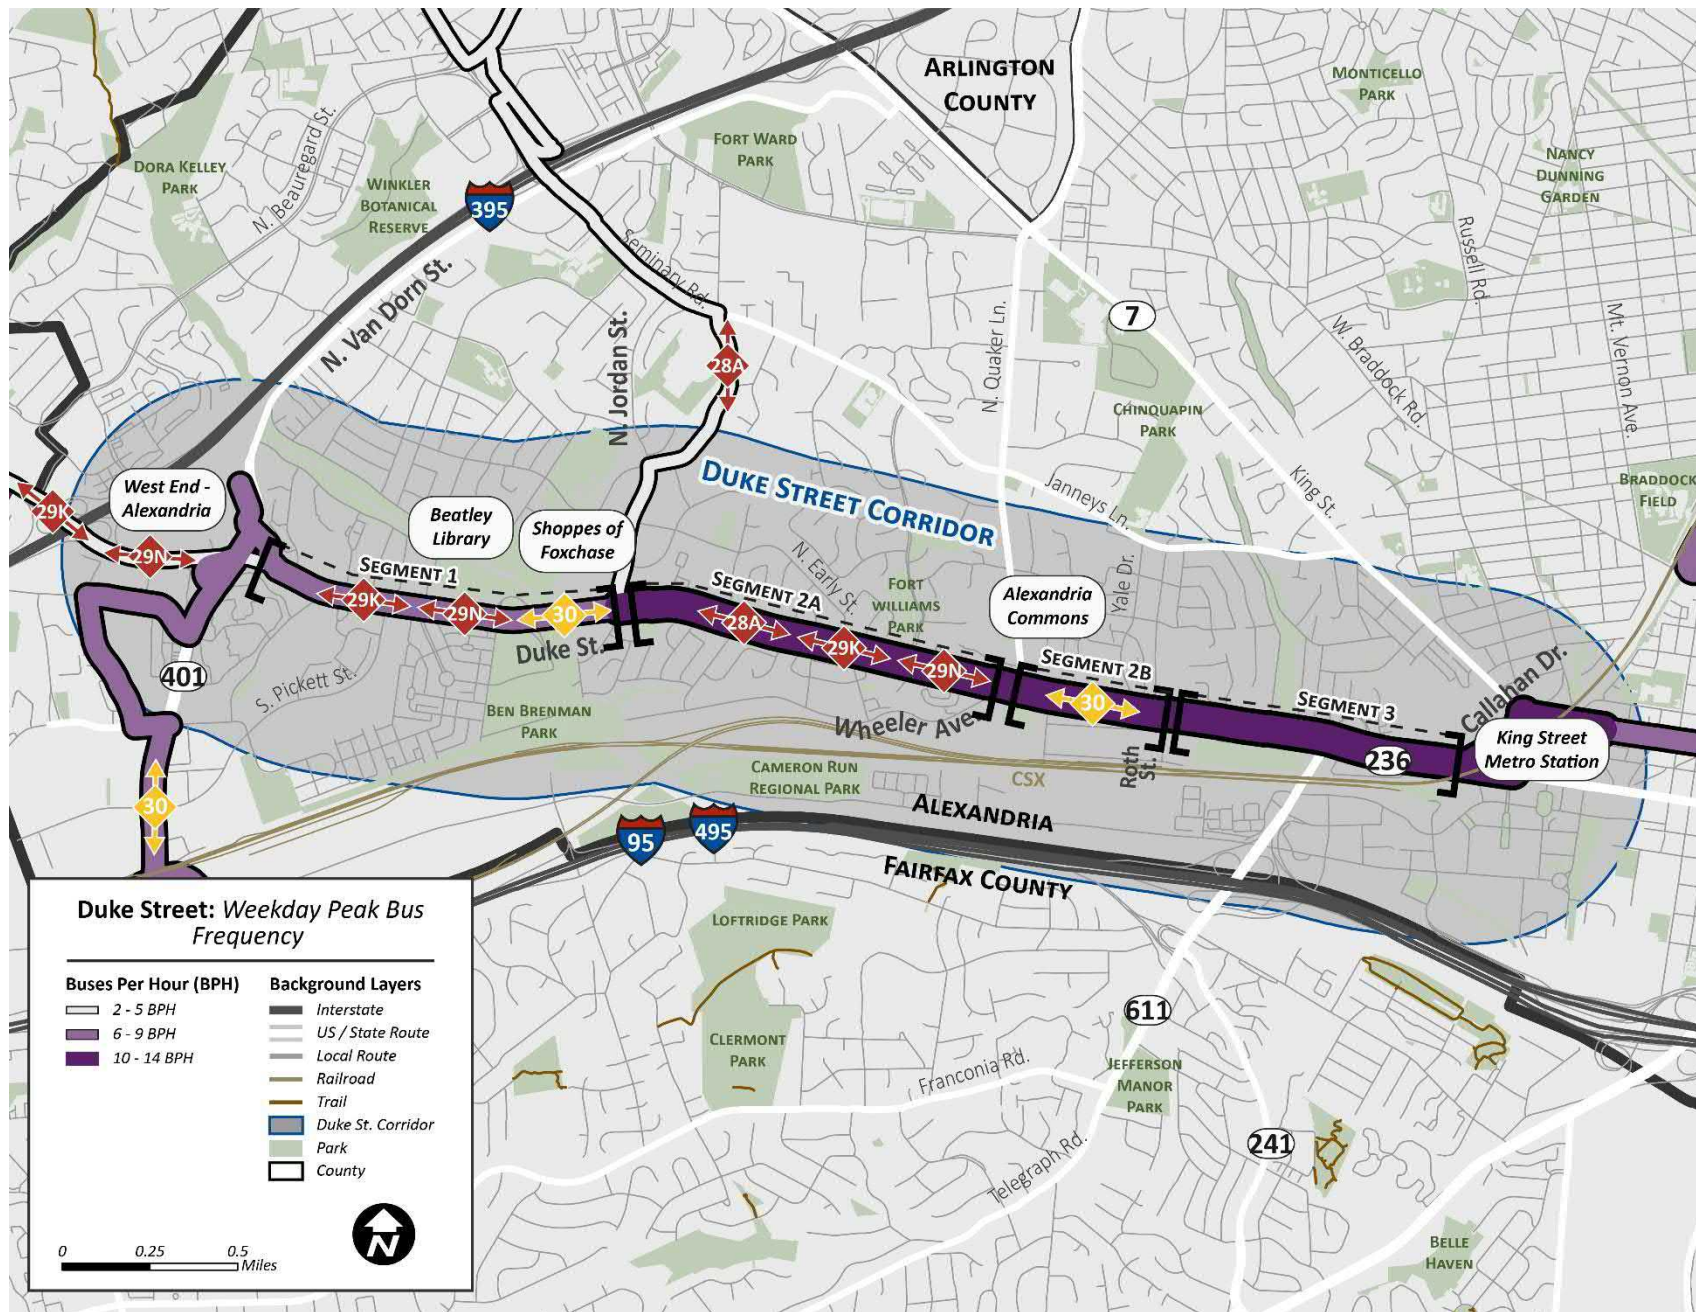
Figure 12: Weekday Peak Bus Frequency, Buses Per Hour (Data Sources: DASH and WMATA)

During peak times Segments 2A, 2B, and 3 have the highest buses per hour at 14 due to Metrobus 28A turning onto Duke Street at Jordan Street. West of Jordan Street, along Segment 1, nine buses per hour travel along the Corridor.

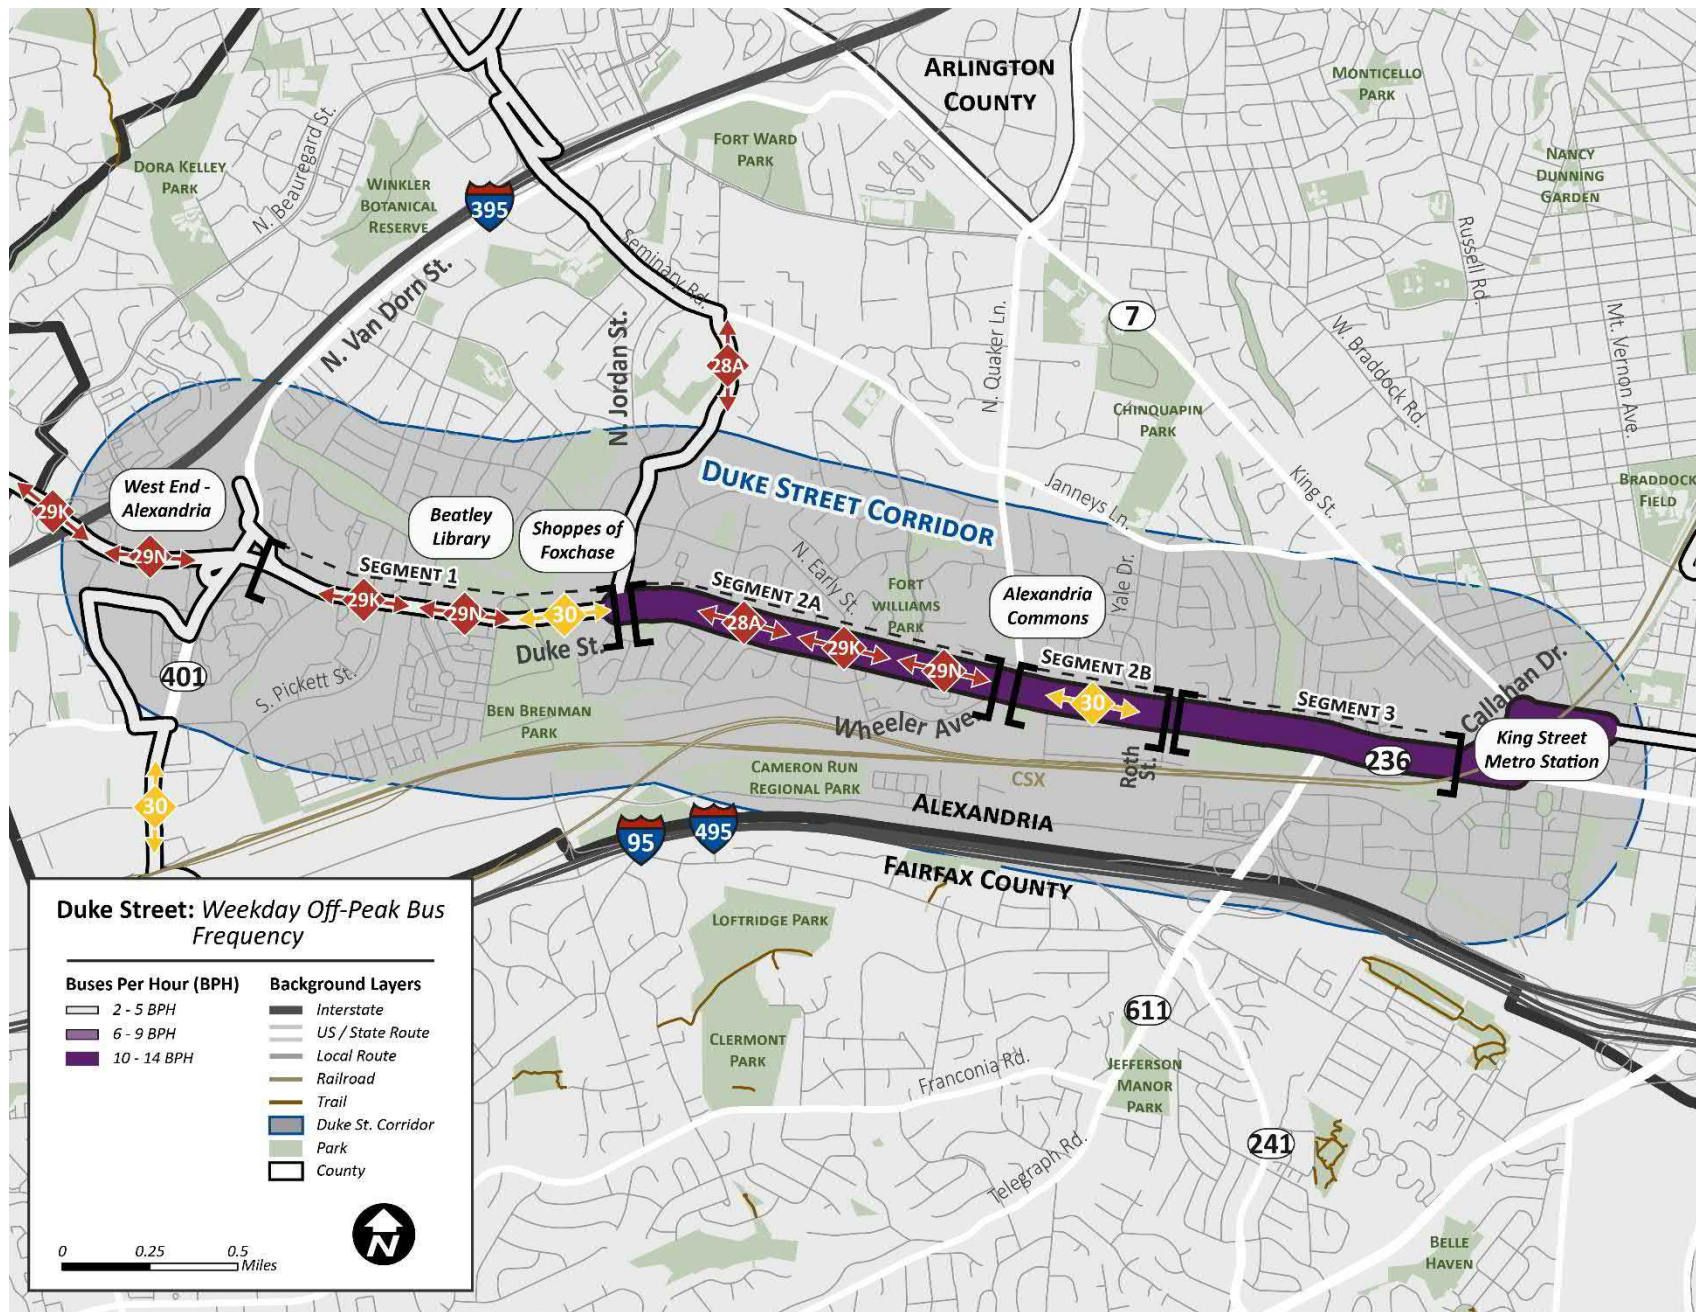
Figure 13: Weekday Off-Peak Bus Frequency, Buses Per Hour (Data Sources: DASH and WMATA)

By comparison, buses per hour travelling along the Corridor are lower during off-peak times due to overall lower headways. Segments 2A, 2B, and 3 again have the highest buses per hour due to 28A turning into Duke Street at Jordan Street with 10 buses per hour. West of Jordan Street, 5 buses per hour travel along the Corridor.

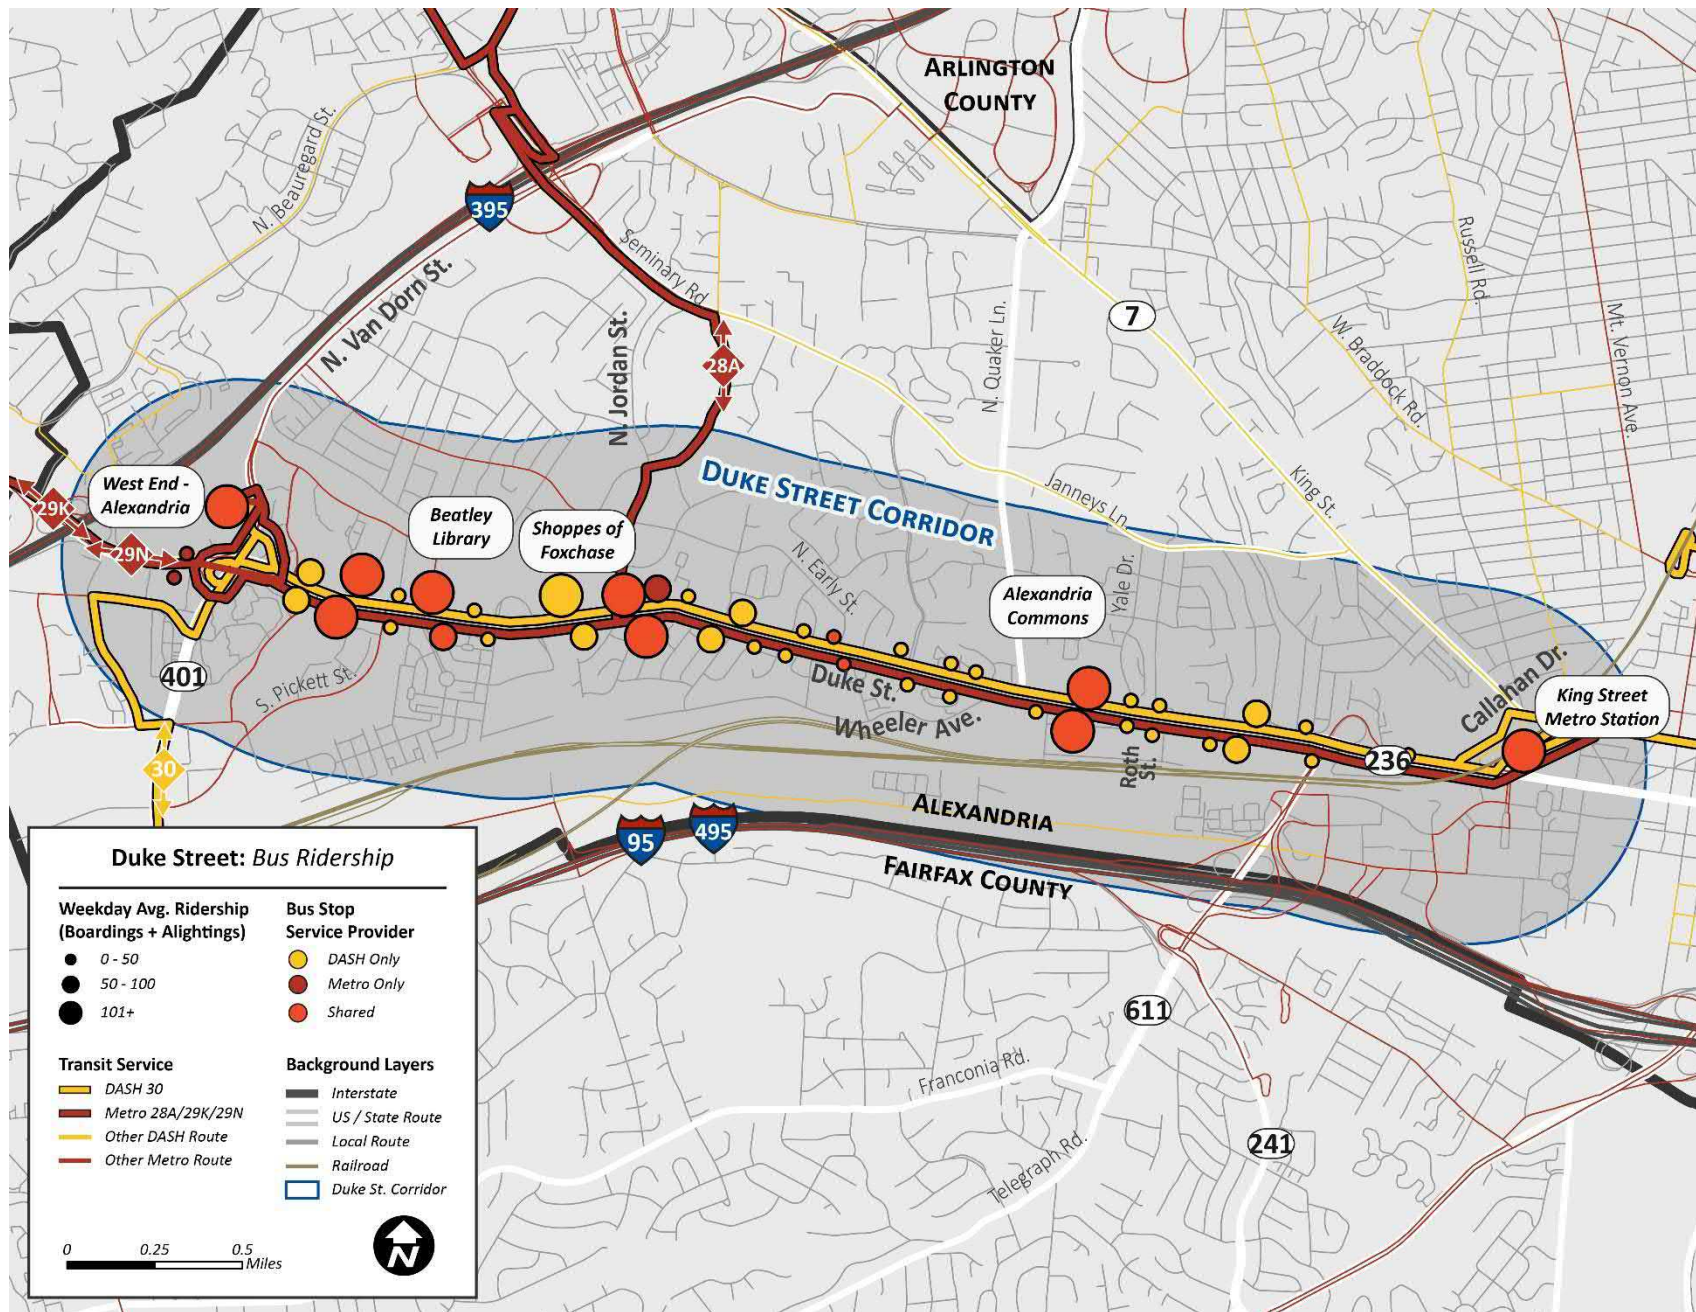
Figure 14: Existing Bus Ridership (Data Sources: DASH and WMATA)

King Street Metro Station and the current Landmark Transit Center (site of the future WestEnd Alexandria development) also have significant boarding and alighting activity and are also major transfer locations. Both are likely to continue to be major hubs. The WestEnd Alexandria development, slated to finish construction in 2025<sup>4</sup>, is planned to include significant commercial, residential, and open space. It is also the site of the future Inova Alexandria Hospital campus. King Street Metro Station is already a hub of residential, commercial, office, and park uses. The Station itself and the surrounding area include a grocery store, a drug store, and numerous restaurants and other employers.

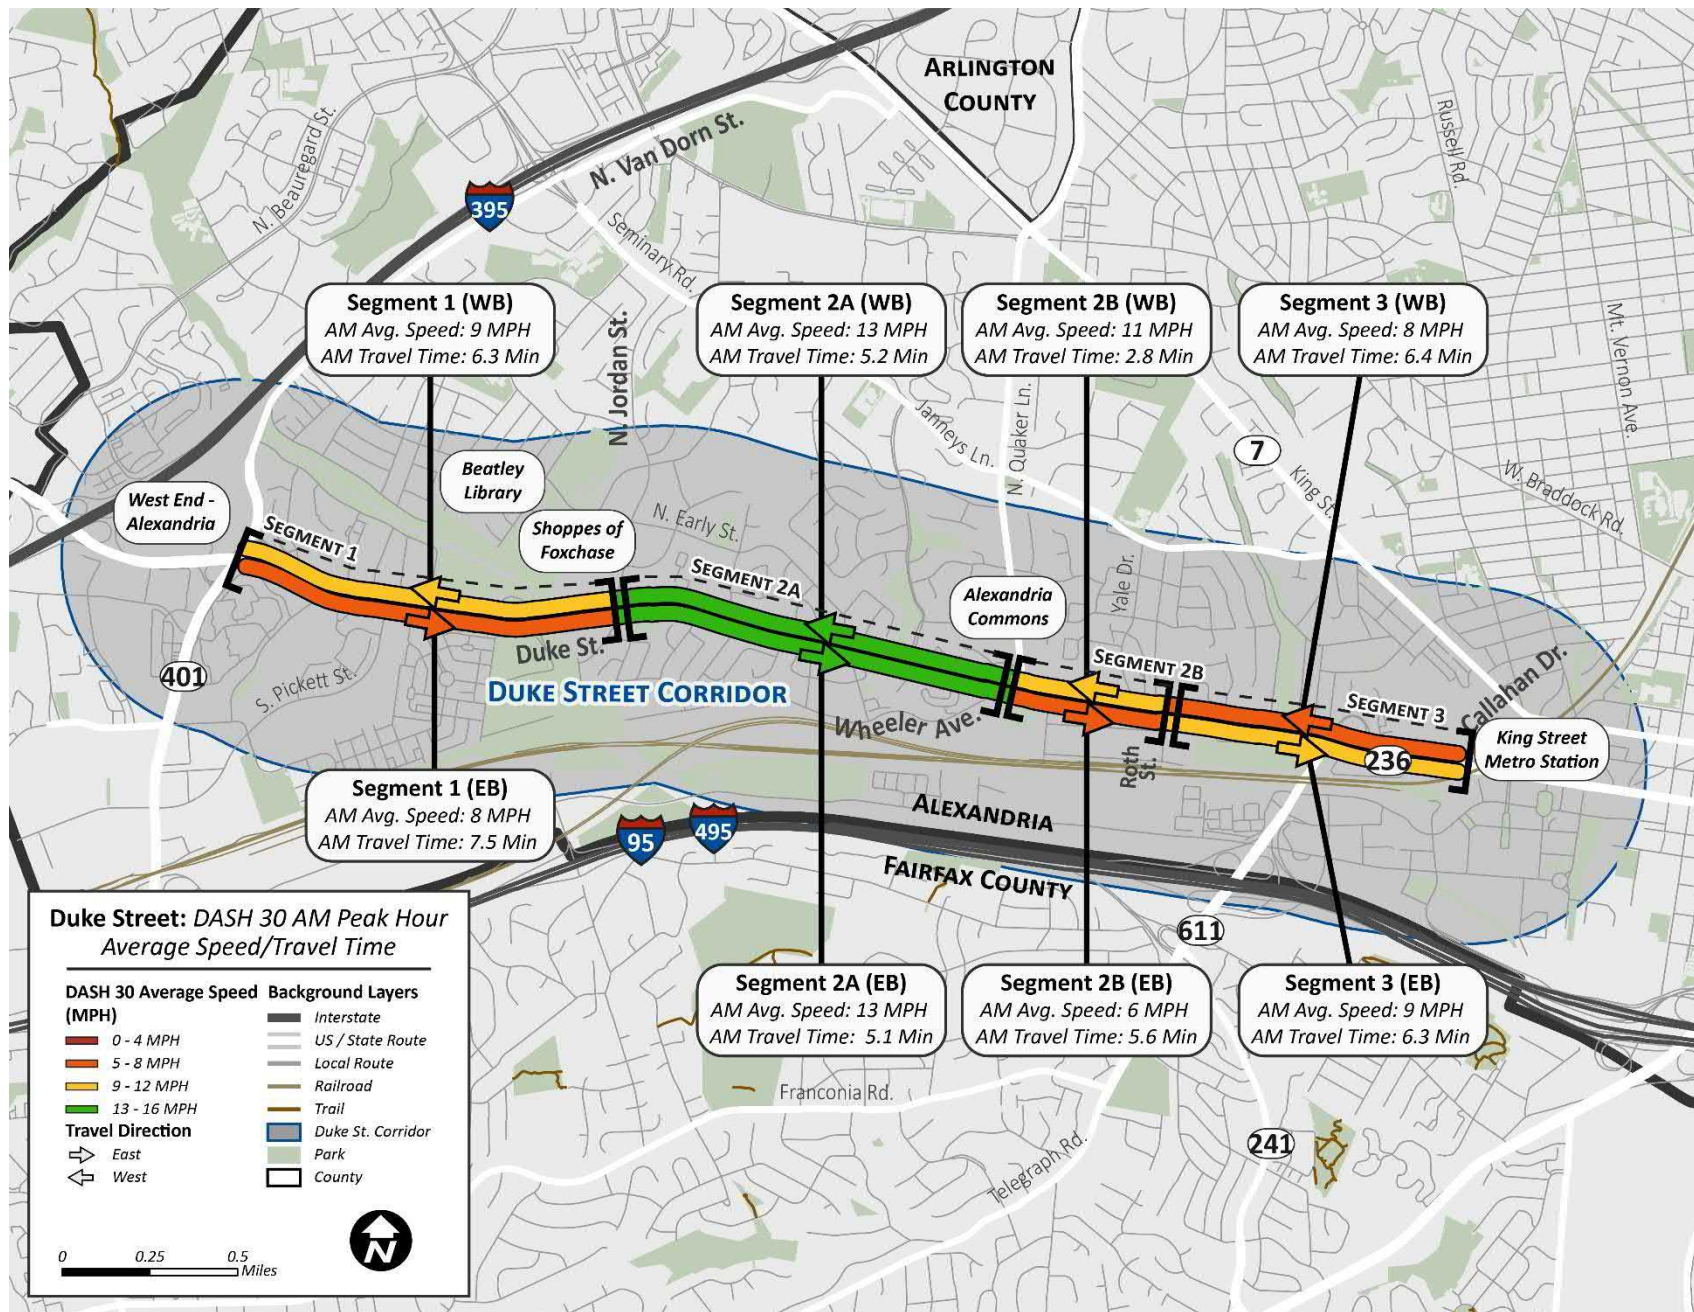
Figure 17: Average AM Peak DASH 30 Travel Time/Speed by Segment (Data Source: DASH)

Travel time and speed data was obtained from DASH to analyze the transit operating conditions along Duke Street, including average peak travel times and speeds along each segment. Average travel speeds and times for the AM and PM periods are shown in **Figure 17** and **Figure 18**, respectively. Westbound and eastbound conditions are symbolized separately.

DASH 30's average travel speeds are universally lower than that of general automobile traffic. As DASH 30 operates in mixed traffic, it is subject to prevailing traffic conditions and is affected by operational challenges throughout the Corridor. Additionally, DASH 30 buses must decelerate and accelerate to pick up passengers and dwell at stops, which slows down travel speeds along the Corridor. These factors highlight the importance of BRT, as dedicated transitway and various measures meant to streamline boarding and alighting reduce delays and make transit more competitive. Removing transit from general traffic, upgrading vehicles, and upgrading stops can enable transit to reach speeds close to general traffic.

AM Peak times along Duke Street are generally worse compared to the same portion of the Corridor during the PM Peak. During the AM Peak, Segments 1, 2B, and 3 are significant bottlenecks, with average speeds clustering around 6-9 MPH. There is generally no large difference in average speed in the EB or WB direction. However, there is a significant difference along Segment 2B. The average WB speed is 11 MPH while the average EB speed is nearly half at 6 MPH. The speed reductions in the EB direction in Segments 2B and 3 can be attributed to the heavy traffic movement from EB Duke Street to SB Telegraph Road, which connects to the Capital Beltway (I-495/I-95). Quaker Lane to Duke Street particularly serves as a connector for cut-through traffic from I-395 to I-495/I-95, and this is reflected in the deterioration in bus speeds in the EB direction in the AM. Segment 2A runs faster than the other segments, averaging 13 MPH in both directions.

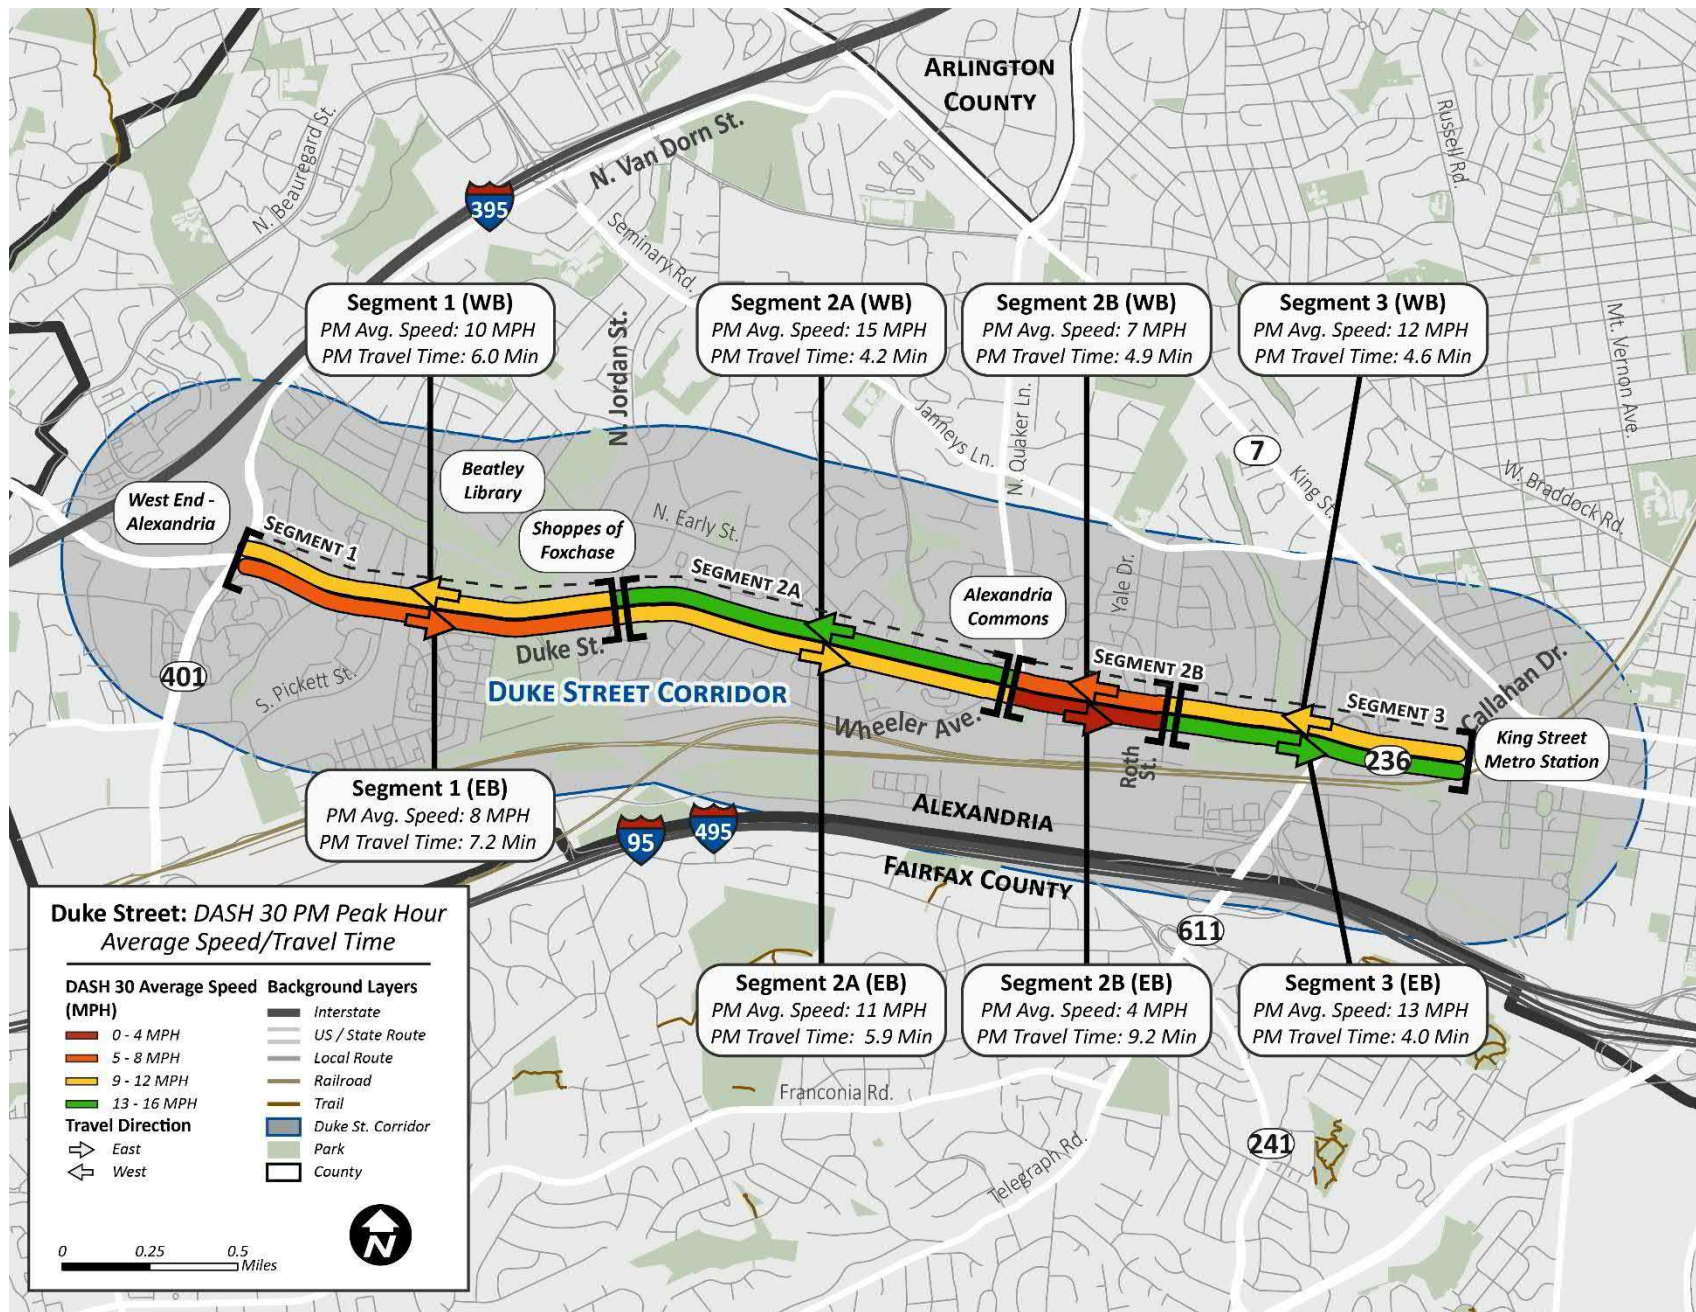
Figure 18: Average PM Peak DASH 30 Travel Time/Speed by Segment (Data Source: DASH)

During the PM Peak, Segments 1 and 2B are again significant bottlenecks, although Segment 3 speeds improve noticeably. Segment 1 speeds are relatively similar to the AM Peak, with 10 MPH WB and 8 MPH EB. Segment 2B speeds worsened compared to the AM Peak, dropping to 7 MPH WB and 4 MPH EB. Again, the speed reductions in Segment 2B can be tied to the cut through traffic between Telegraph Road and Quaker Lane and the connection it provides for cut through traffic between major interstates. Segment 2A again has comparatively high speeds, although the speeds decreased slightly in the EB direction compared to the AM Peak (13 MPH in the AM vs. 11 MPH in the PM).

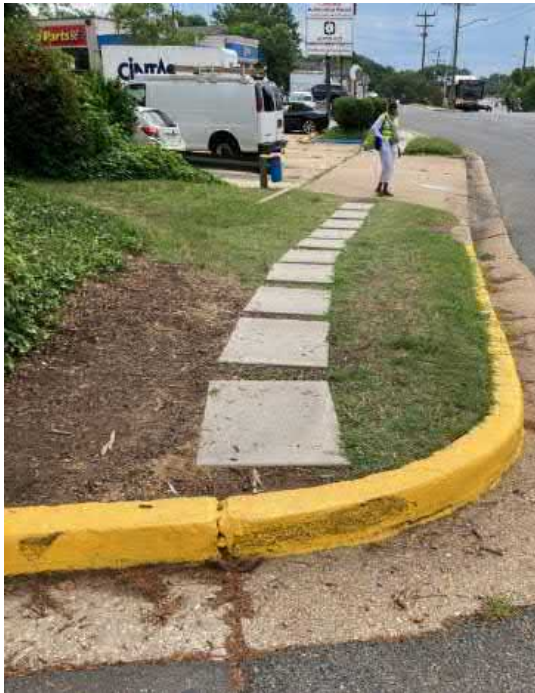
**Figure 20: Example of Sidewalk Near Foxchase Apartments Rated as “Needs Improvement” (Photo Source: Toole Design)**

- Partially Missing: Indicates a segment where at least part of the segment has no sidewalks
- Needs Improvement: Indicates when a segment has at least one of the following conditions: poor surface quality, narrow width, lack of buffering from street, physical obstructions, or multiple curb cuts for driveways
- Fair Condition: Indicates a segment where connectivity was continuous, and sidewalks did not suffer from any of the conditions listed under “Needs Improvement”

For reference, see **Figure 20** and **Figure 21** for examples of sidewalks rated as “Needs Improvement” and “Fair”, respectively, that were observed during the field review.

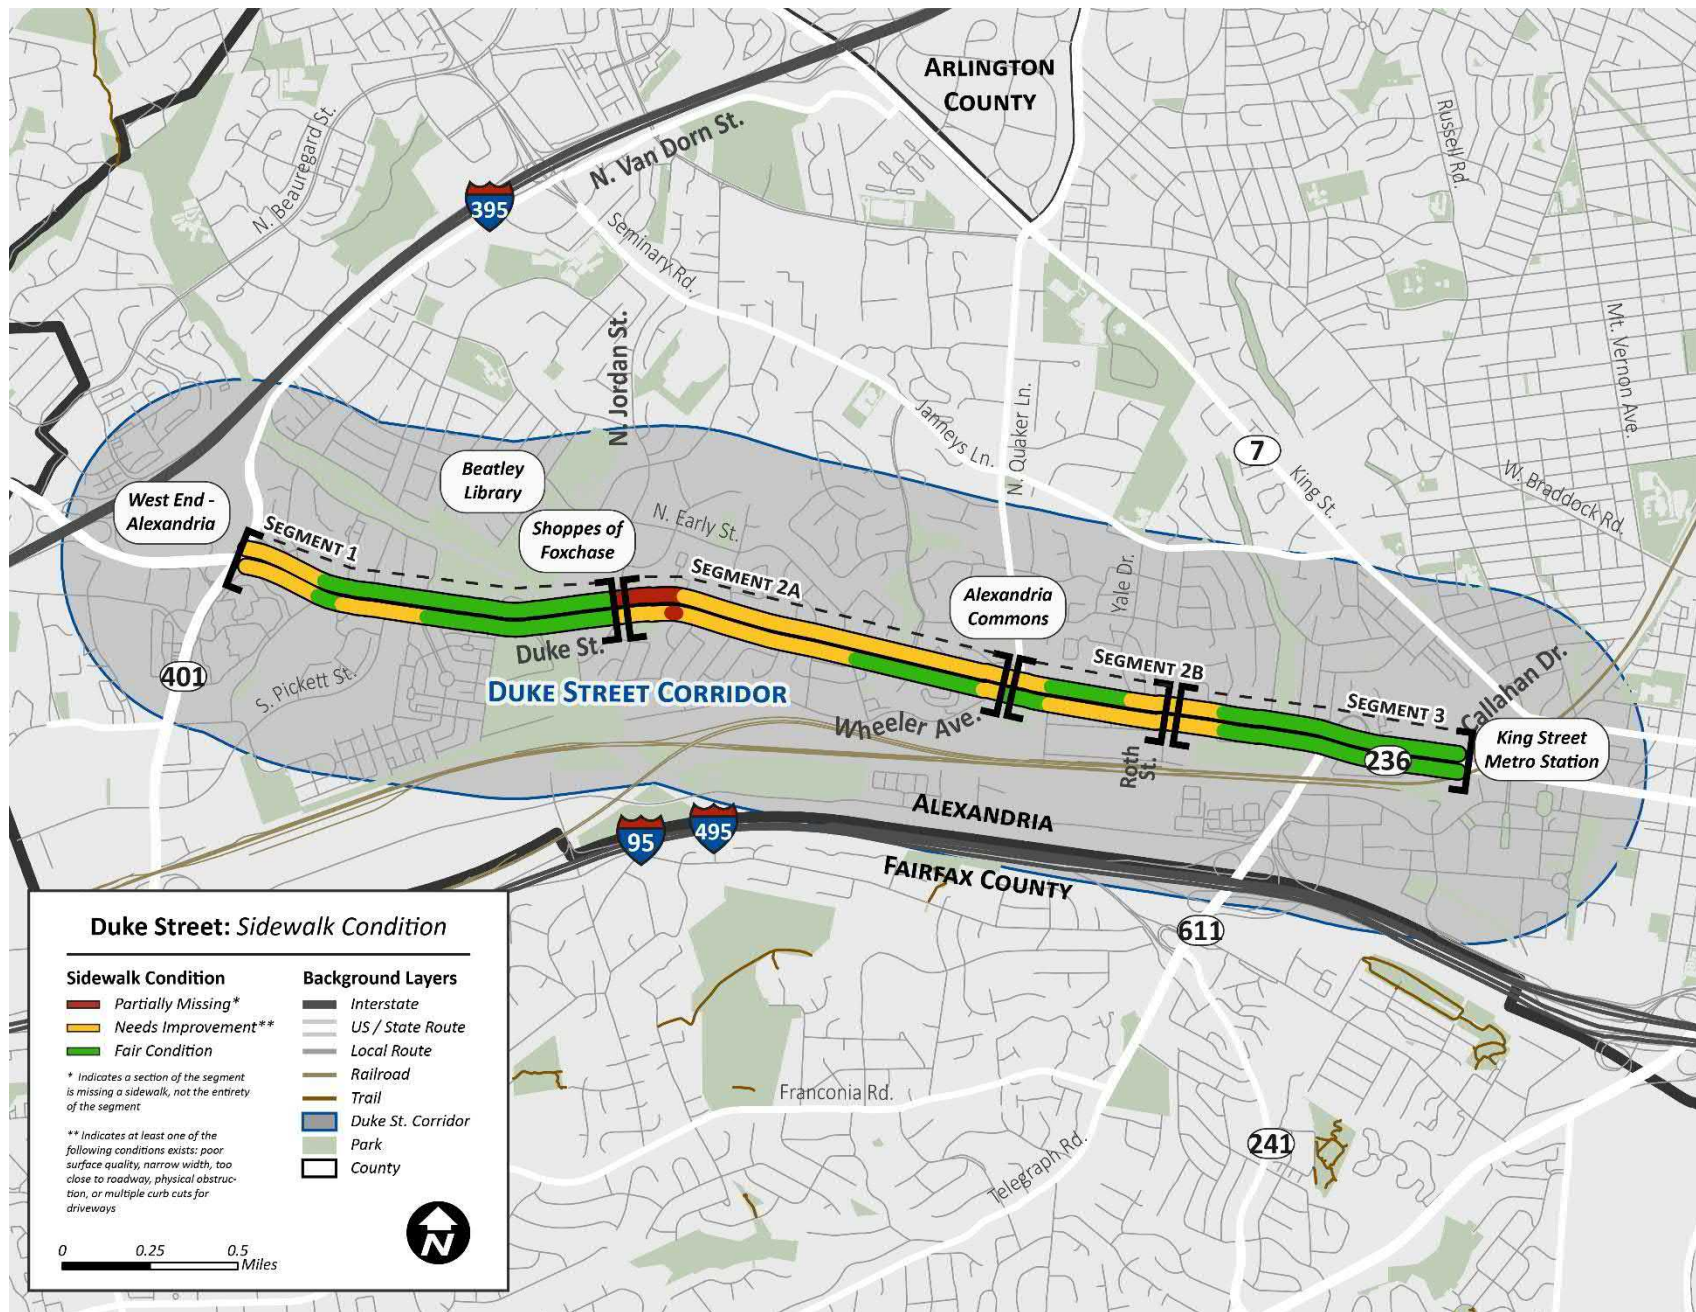
**Figure 22** below displays sidewalk conditions along Duke Street as of July 6, 2022. Duke Street largely has continuous sidewalk coverage, although there are small gaps directly east of Jordan Street, where both sides of Duke Street do not have sidewalks for a short distance due to the presence of a frontage road. Aside from this section, sidewalks are continuous along the rest of the corridor, with approximately 97% of the corridor having continuous sidewalks (see **Table 6**). Sidewalks along Segments 2A and 2B particularly suffer from the issues identified under the “Needs Improvement” category above. Significant portions of Segments 1 and 3 were rated as being in “Fair Condition.” Issues were identified near the Van Dorn Street interchange and Telegraph Road interchange along Segments 1 and 3, respectively. Interchange ramps tend to be inhospitable for pedestrians, who require special accommodation in such areas in face of large traffic volumes, higher speeds, and insufficient traffic control devices.
